Moraga Country Club  
Club  
*Moraga , CA*

Report #: 18931-4  
Beginning: January 1, 2023  
Expires: December 31, 2023

RESERVE STUDY  
Update "No-Site-Visit"

November 22, 2022

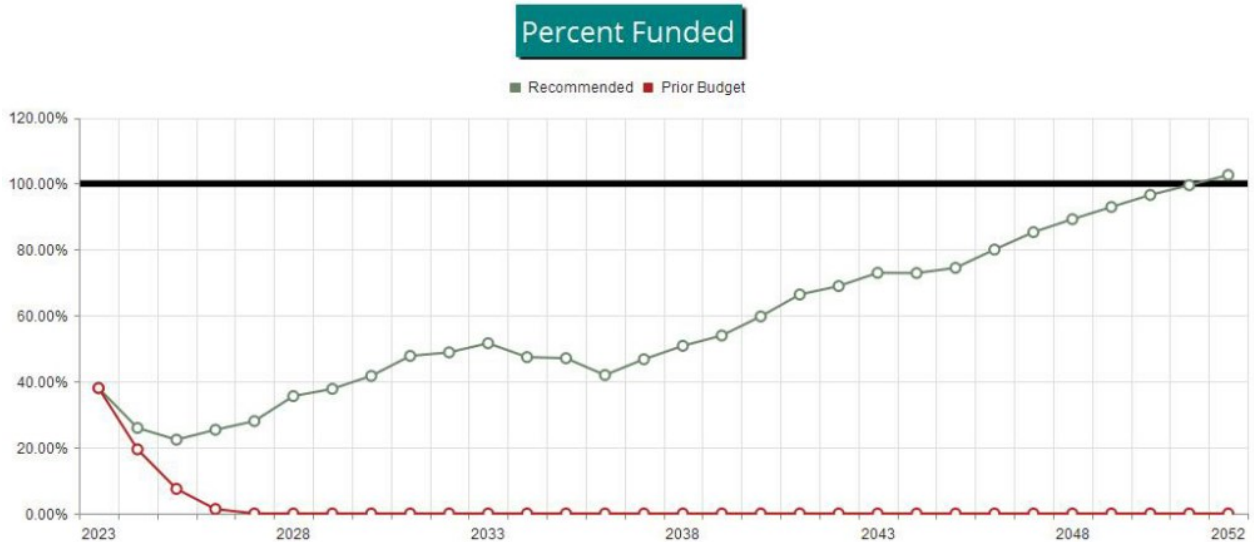
Figure 4

This figure shows the same information plotted on a Percent Funded scale. It is clear here to see how your Reserve Fund strength approaches the 100% Funded level under our recommended multi-yr Funding Plan.
